Tech Note

Rev 1.0 Dec21

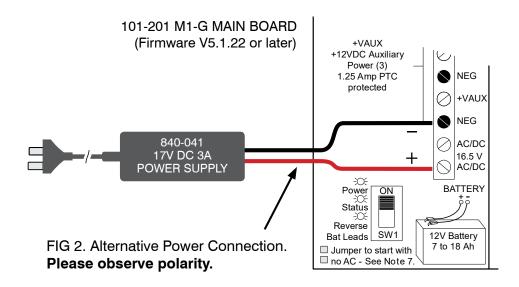
Note. An M1 board failing to power up may be caused by normal variations in component tolerances in the power supply or the M1 board. Connecting the power supply as per Fig 2. will remedy the issue in most cases.

In cases where an M1-G main board fails to power up normally, the **17VDC** power supply can be connected as shown in Fig 2. (power supply negative to AUX NEG)
