Tech Note

Rev 1.0 Dec21

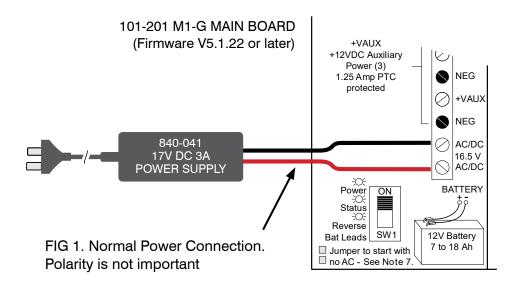
In cases where an M1-G main board fails to power up normally, the **17VDC** power supply can be connected as shown in Fig 2. (power supply negative to AUX NEG)

Note. An M1 board failing to power up may be caused by normal variations in component tolerances in the power supply or the M1 board. Connecting the power supply as per Fig 2. will remedy the issue in most cases.
